SITE INSPECTIONS WERE LIMITED TO VISUAL OBSERVATIONS ON JANUARY 29TH, 2015 AND REPRESENTS THE CURRENT CONDITIONS BASED ON OUR PROFESSIONAL OPINION.

2016 BULKHEAD REPAIRS PROJECT
 FLAMINGO ISLES MUD
 HITCHCOCK, TEXAS

DATE:	02/05/16
SCALE:	1:250
DWG:	EX 1.00
JOB NO:	16-103
REV:	A

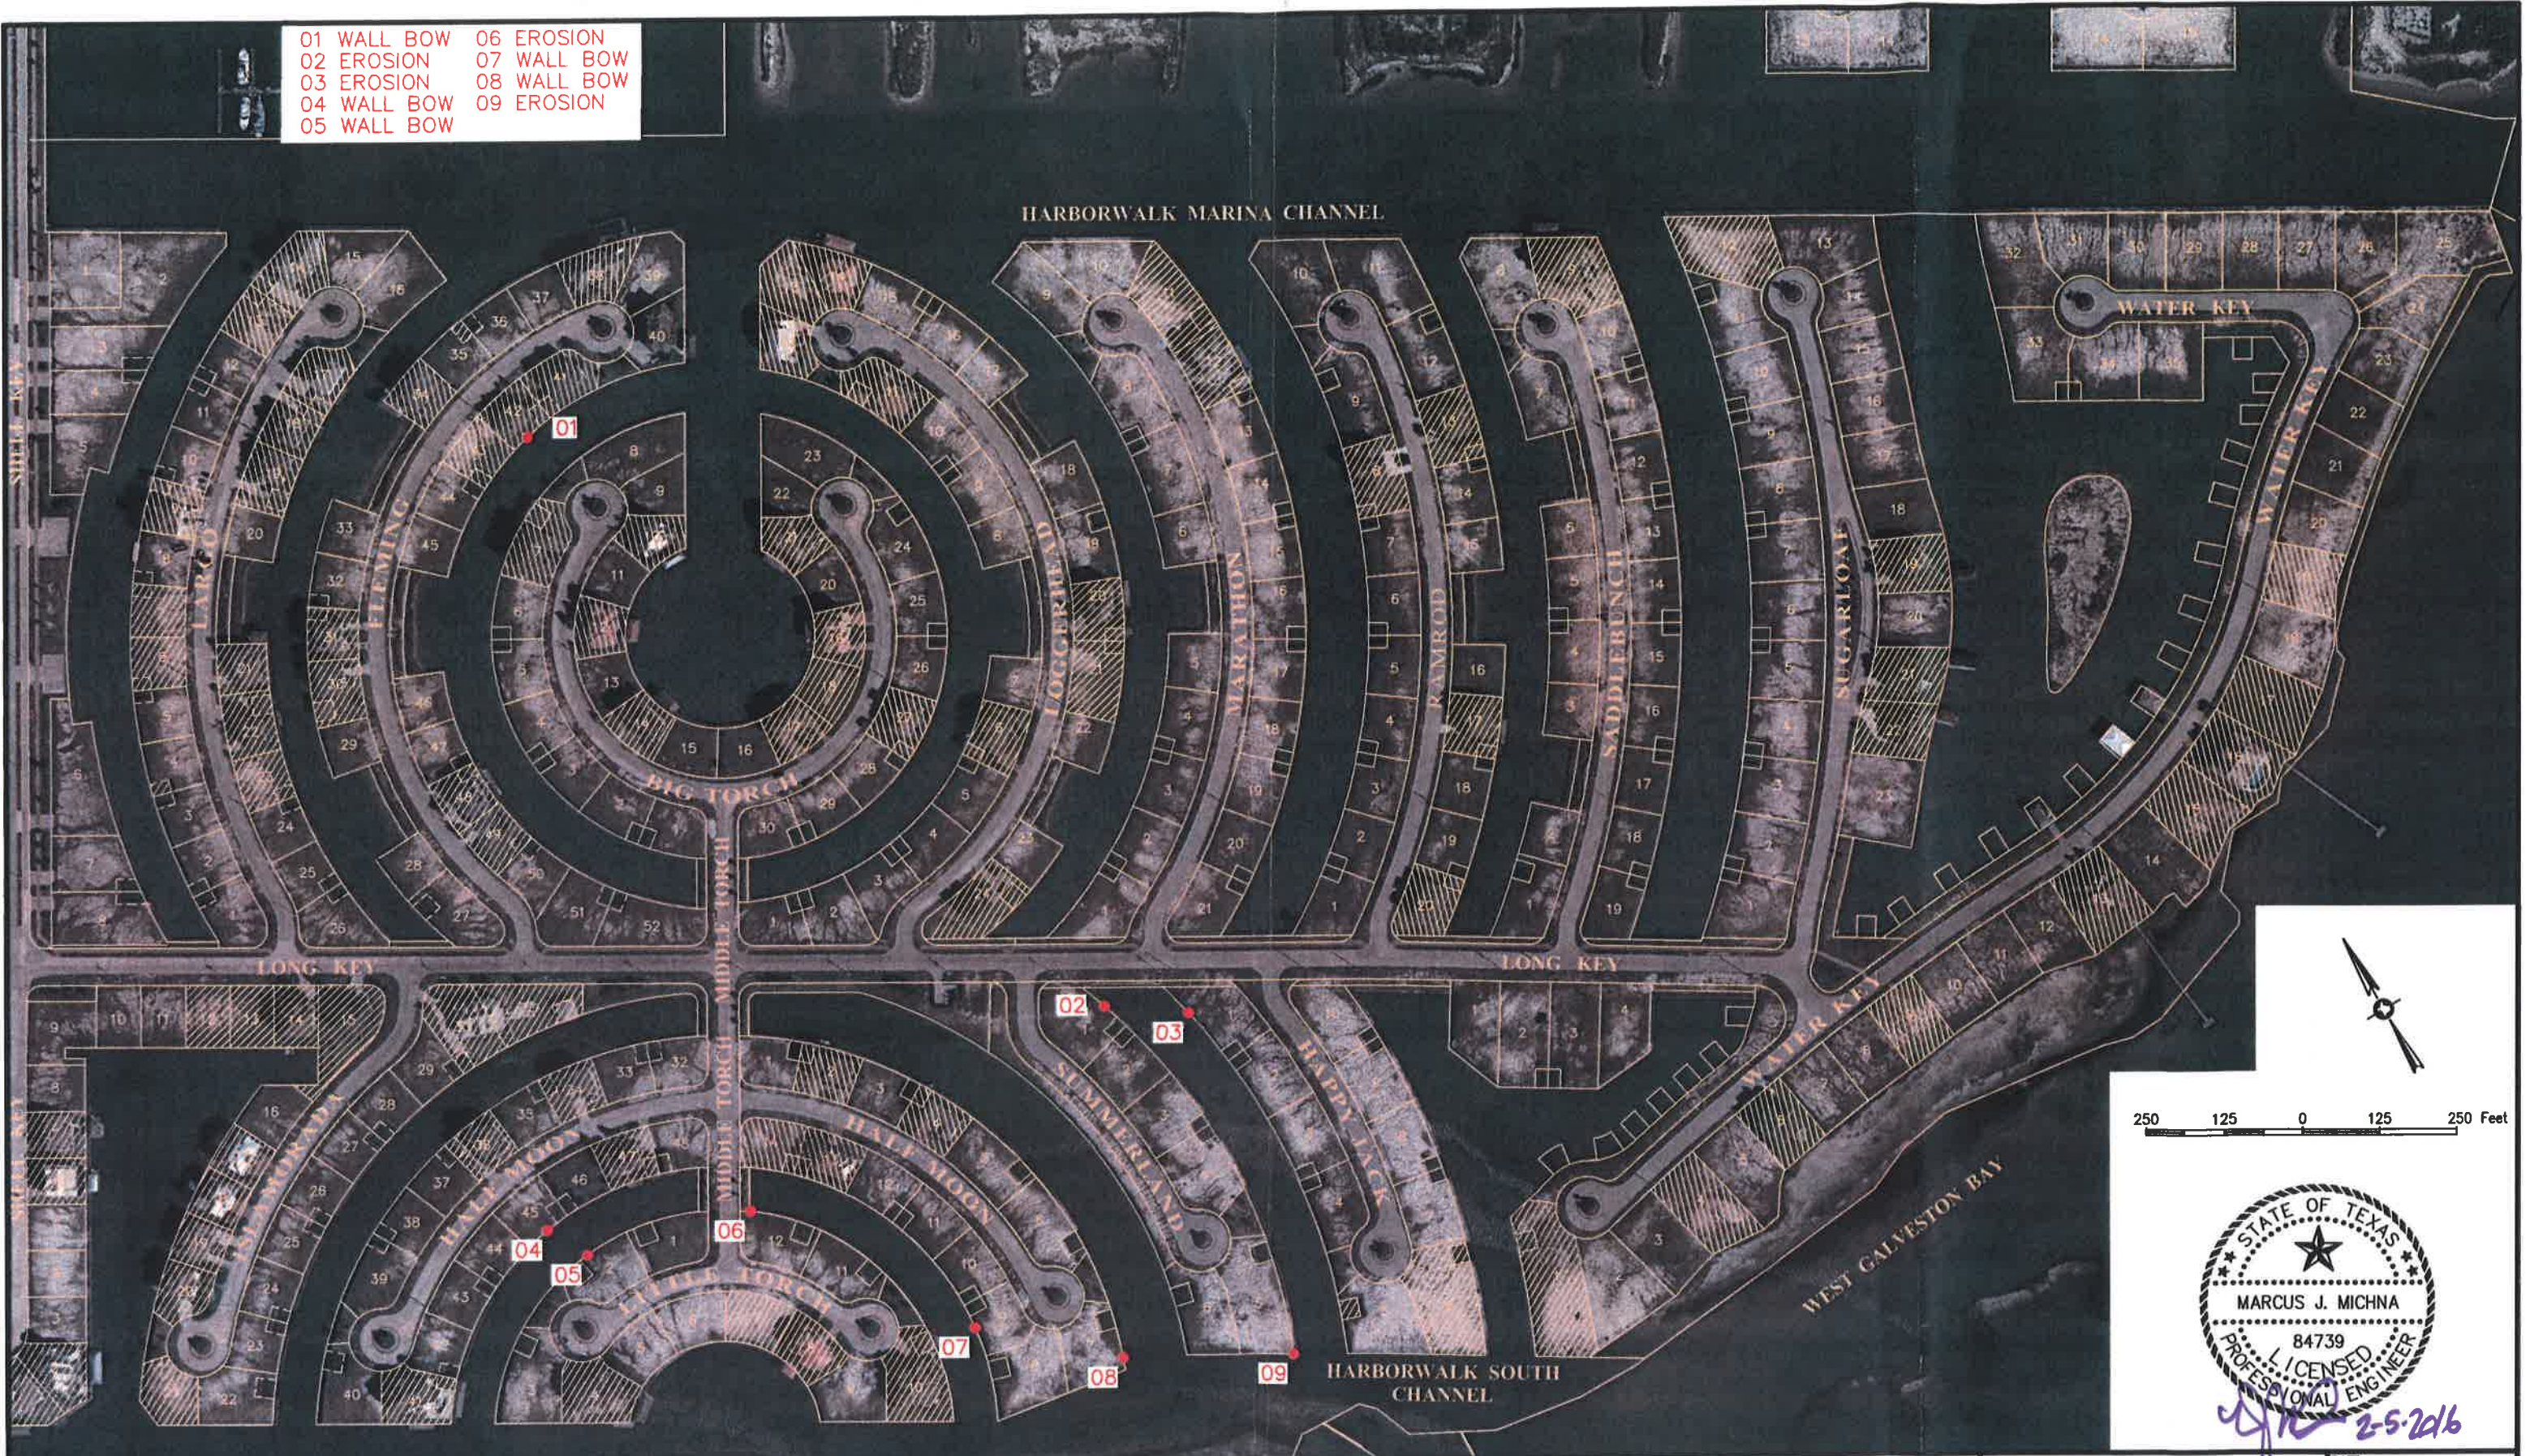
- 01 WALL BOW
- 02 EROSION
- 03 EROSION
- 04 WALL BOW
- 05 WALL BOW
- 06 EROSION
- 07 WALL BOW
- 08 WALL BOW
- 09 EROSION

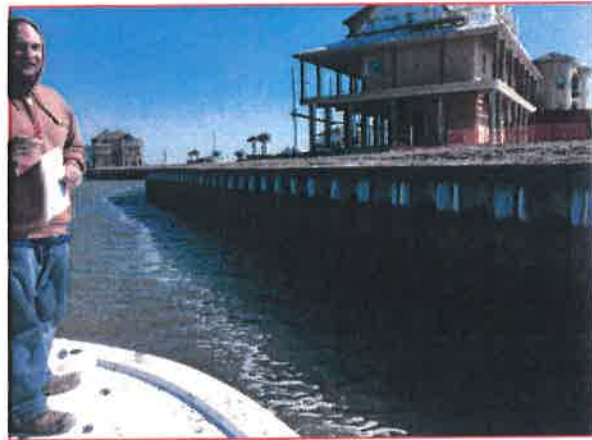
1 WALL BOW

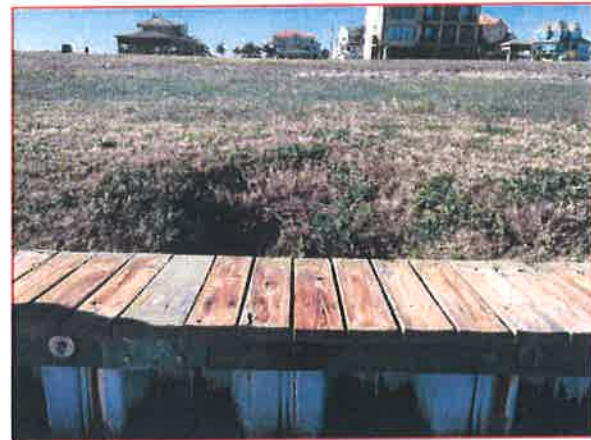
2 EROSION

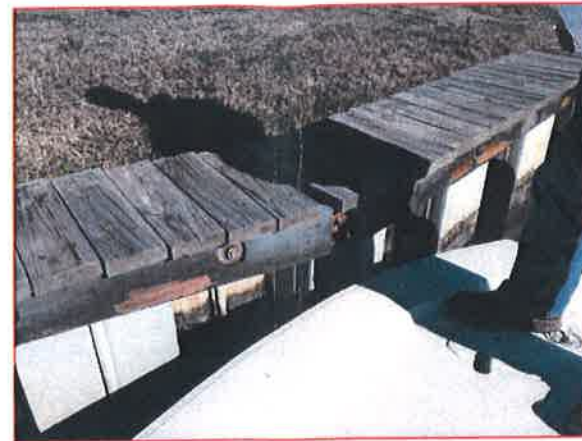
4 WALL BOW

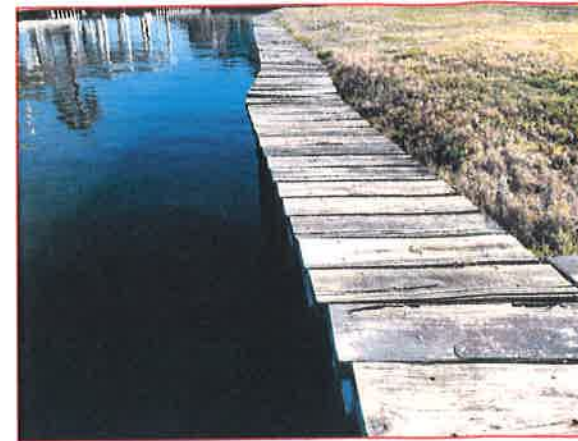
5 WALL BOW

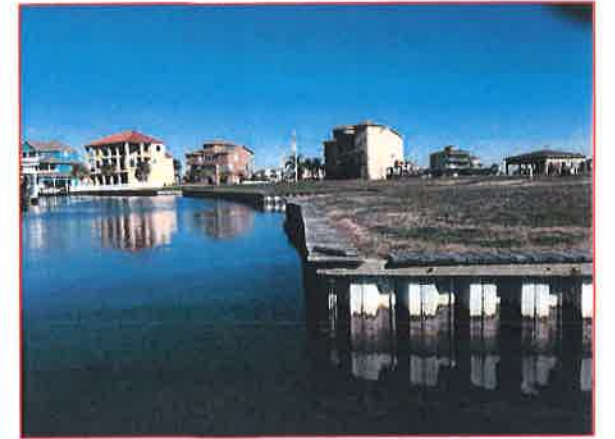
7 WALL BOW

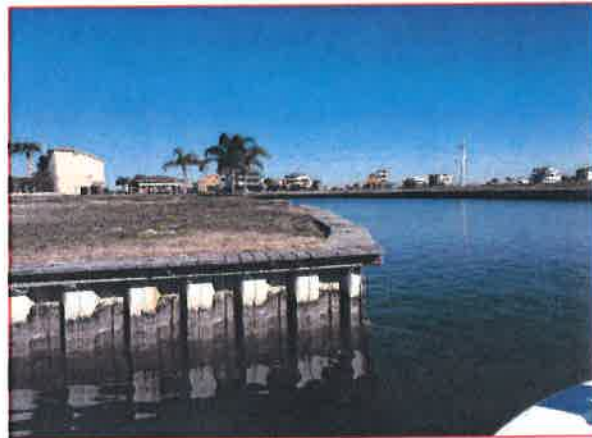
8 WALL BOW

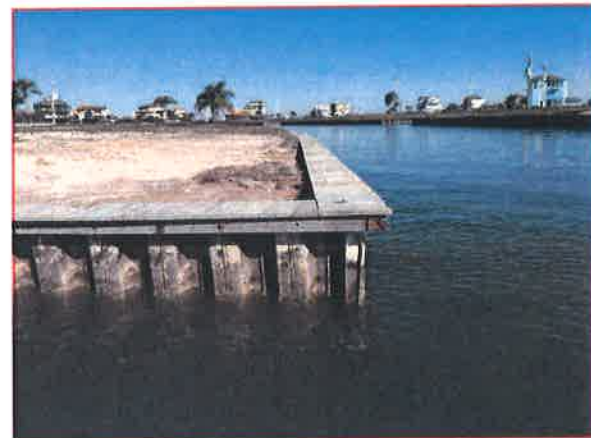
9 EROSION

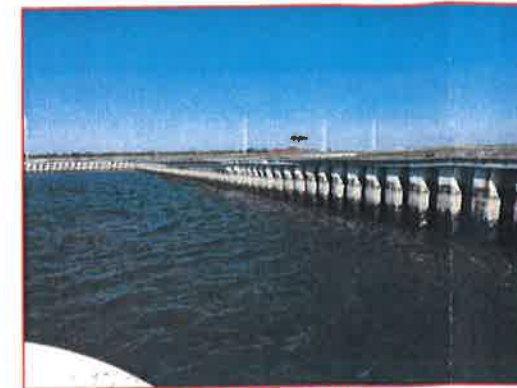
10 WALL BOW
